LOSSAN North Corridor Coastal Stabilization Update

May 16, 2023

Coastal Stabilization Efforts

*LOSSAN Corridor
North*

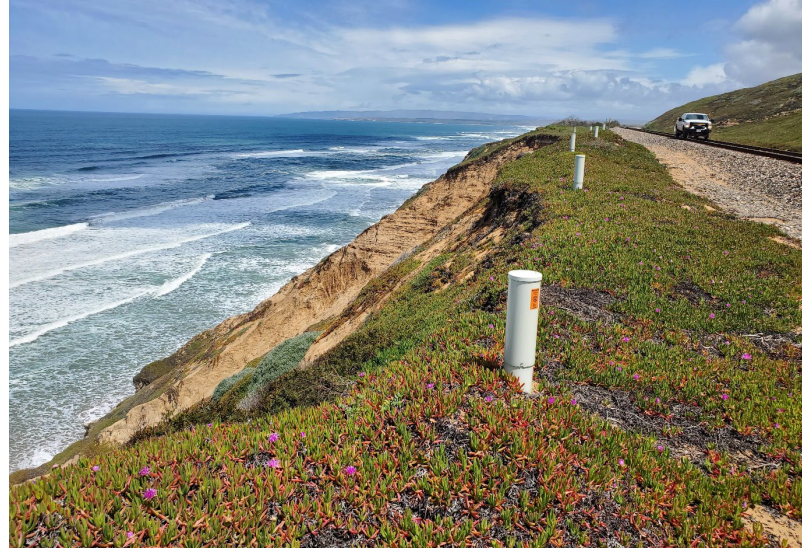
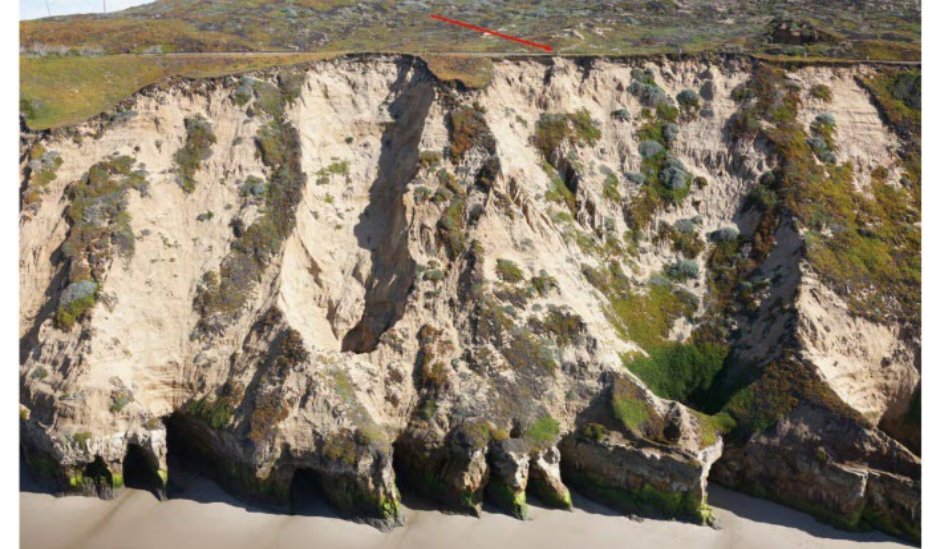
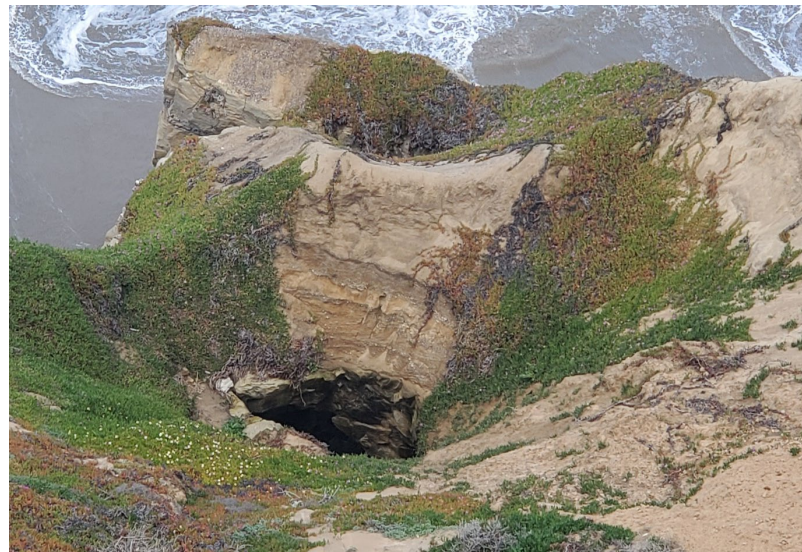
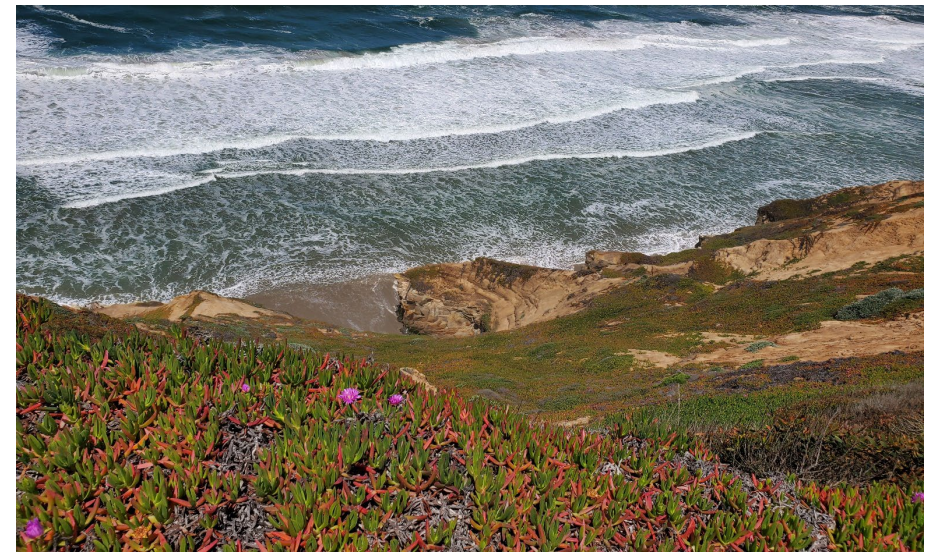
Honda Bluff Repairs and Potential Track Relocation (Mile Post 302-303)

- Shoreline erosion in sandstone formation
- Failure of steep sandy slopes

- Install slope failure monitors.
- Daily monitoring

- Relocate tracks inland
- Protect shoreline ~1500ft of shoreline
- Fill voids in sea caves
- May need VSFB, USACE, CCC, and State Lands permits

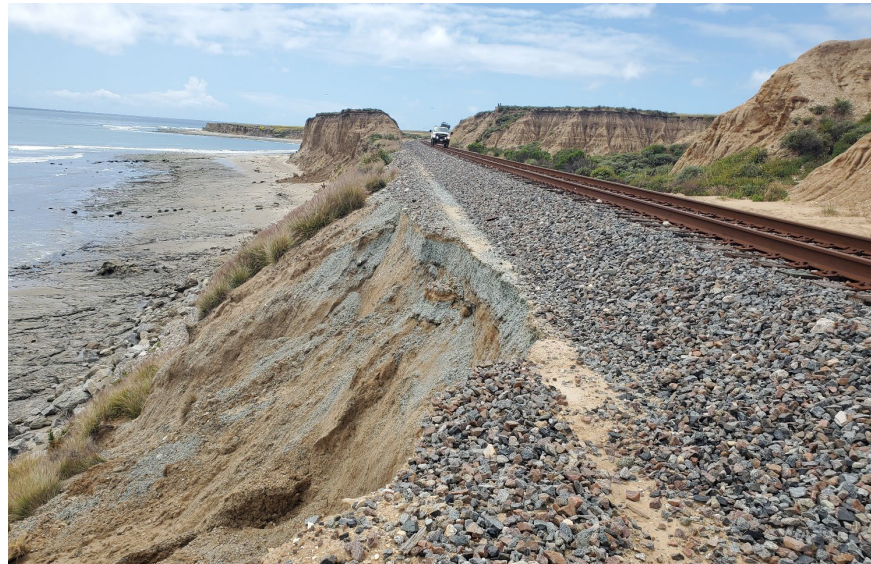
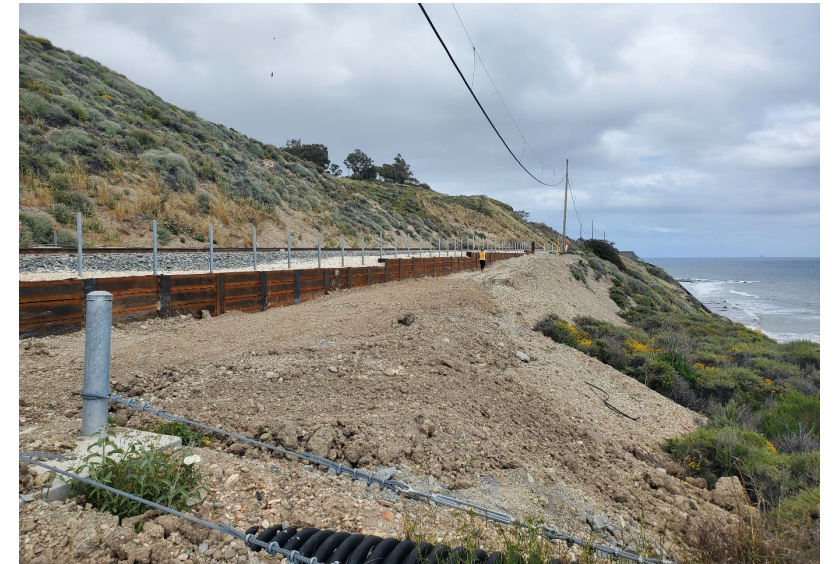
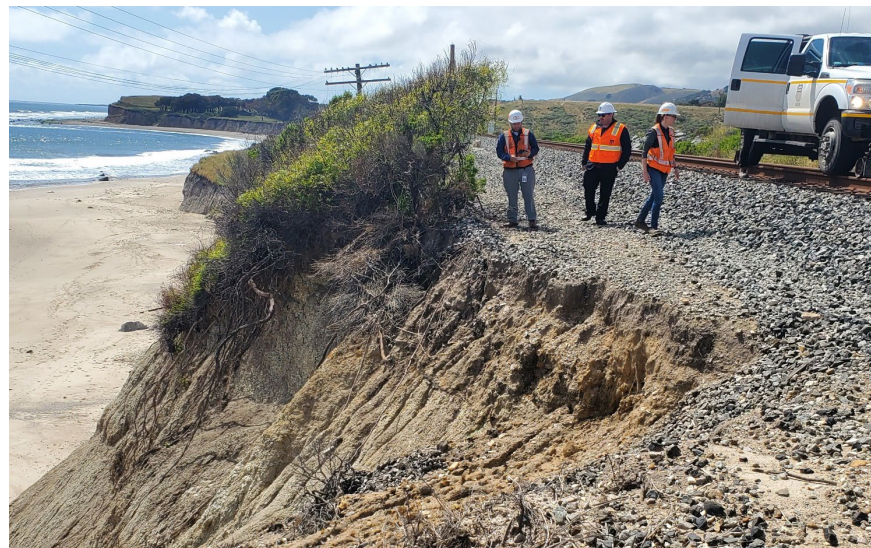
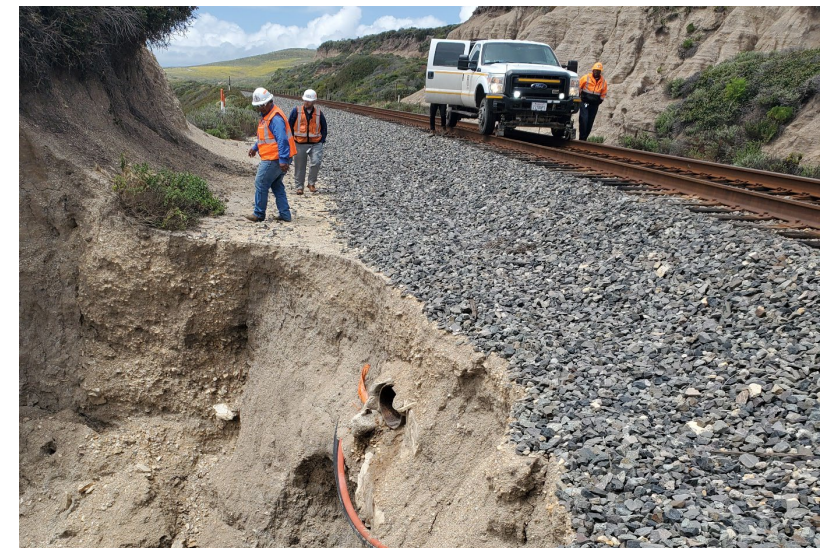
Hollister Ranch Repairs (Mile Post 324-329)

- Significant Bluff Erosion
- Loosing Slope within 8ft of Rail
- Erosion Moving Laterally
- Failure of Historic Seawall

- Short to intermediate term repair includes construction of a soldier pile wall high on the bluff face (at Sacate)

- Extend soldier pile and install tie-backs under the tracks.
- Replace drainage pipes
- Repair seawalls, where damaged
- Seawall work will need USACE, RWQCB, and CCC permits

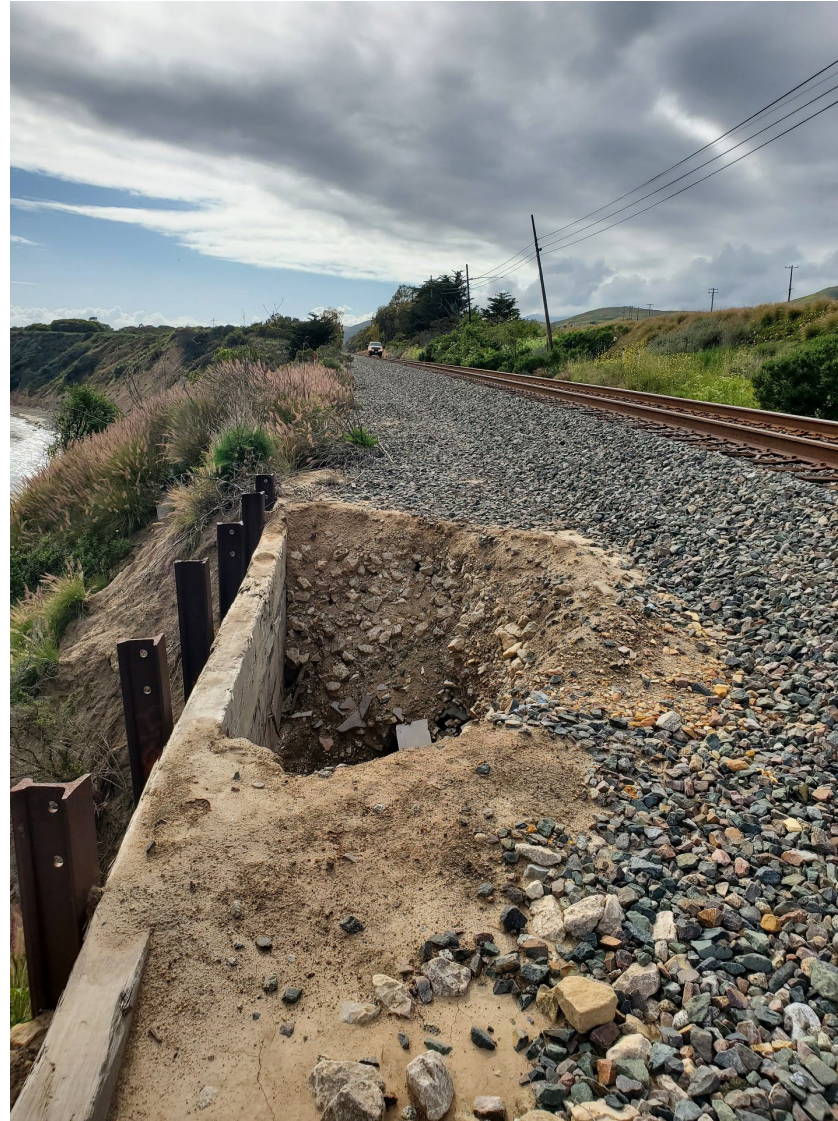
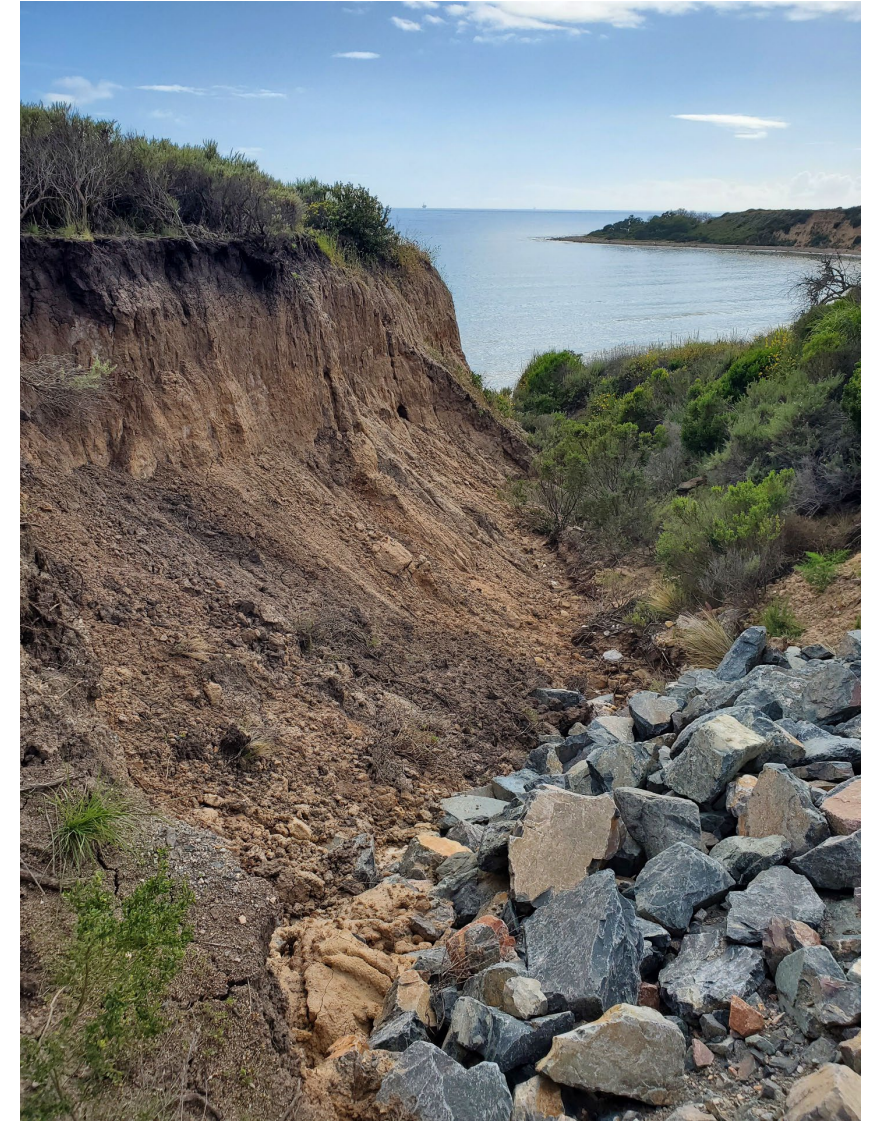
El Capitan Bluff (Mile Post 347-348)

- Scour under wooden soldier pile wall
- Pipe broken above seawall
- Slope eroding away approximately 6' to 8' away from track

- Fill void with rip-rap

- Replace pipe and headwall (built in 1916).
- Replace wood wall with concrete soldier pile wall with tie-back anchors. Fill scour hole with rock, or gabion mattress

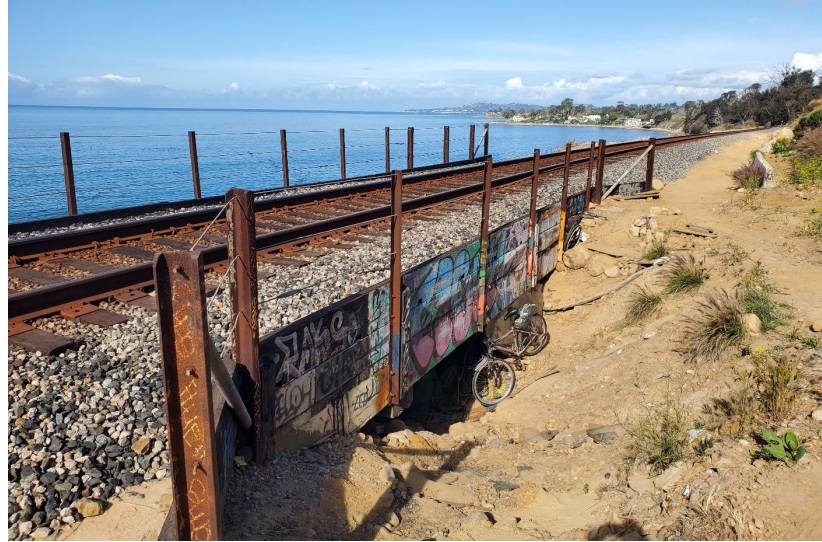
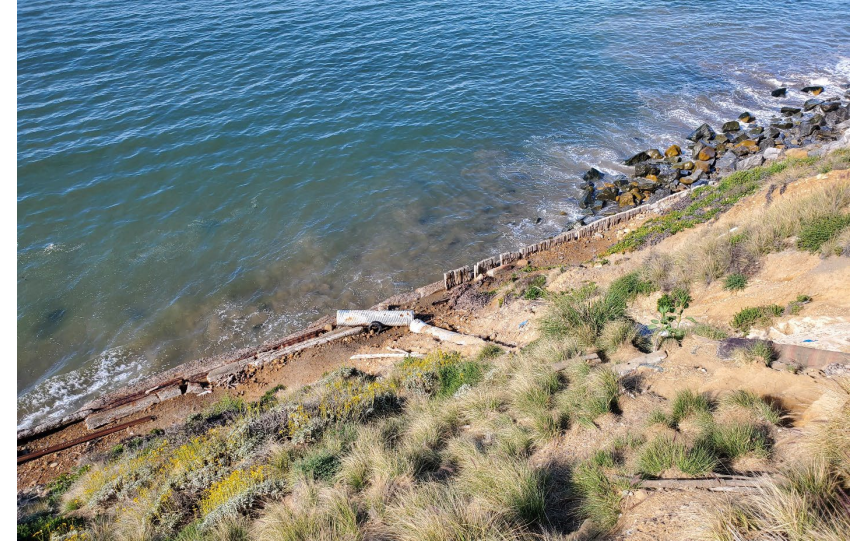
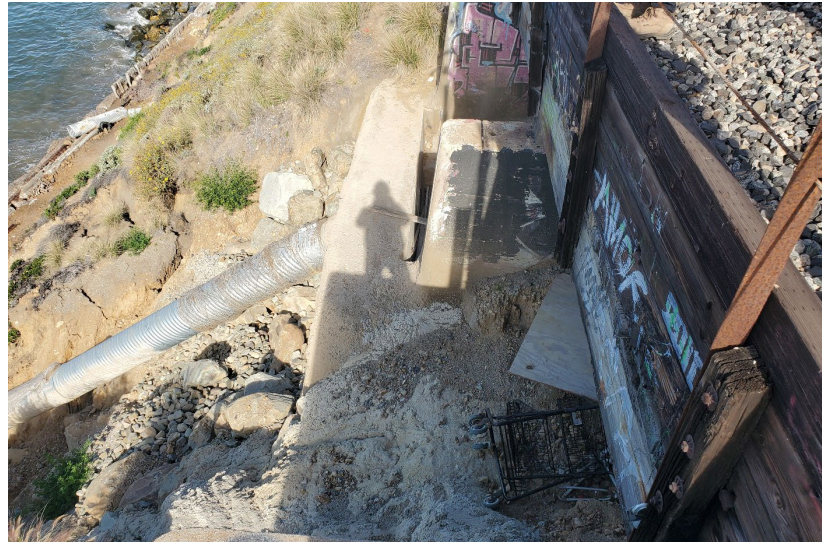
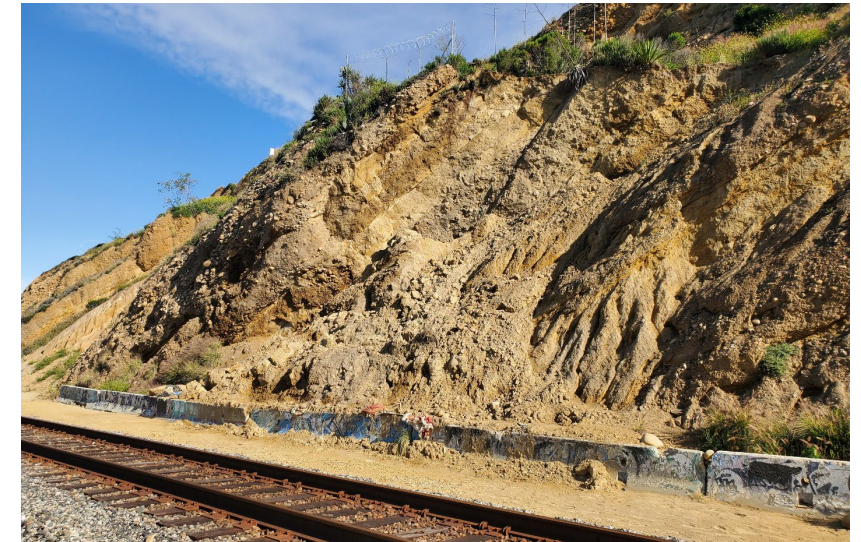
Ortega Hill (Mile Post 372-373)

- Slope erosion due to existing failing storm drains
- Slope erosion due to surface water is causing erosion of shoulder and causing a loss of ballast
- Existing void under bridge creating instability

- Removal of blockage under tracks causing additional erosion on hill side

- Replacement of corrugated metal pipes with proper headwalls and anchors to toe of slope.
- Add drilled pier to secure in slope
- Stabilize bluff face with soil netting.
- Fill in the void under bridge concrete floor

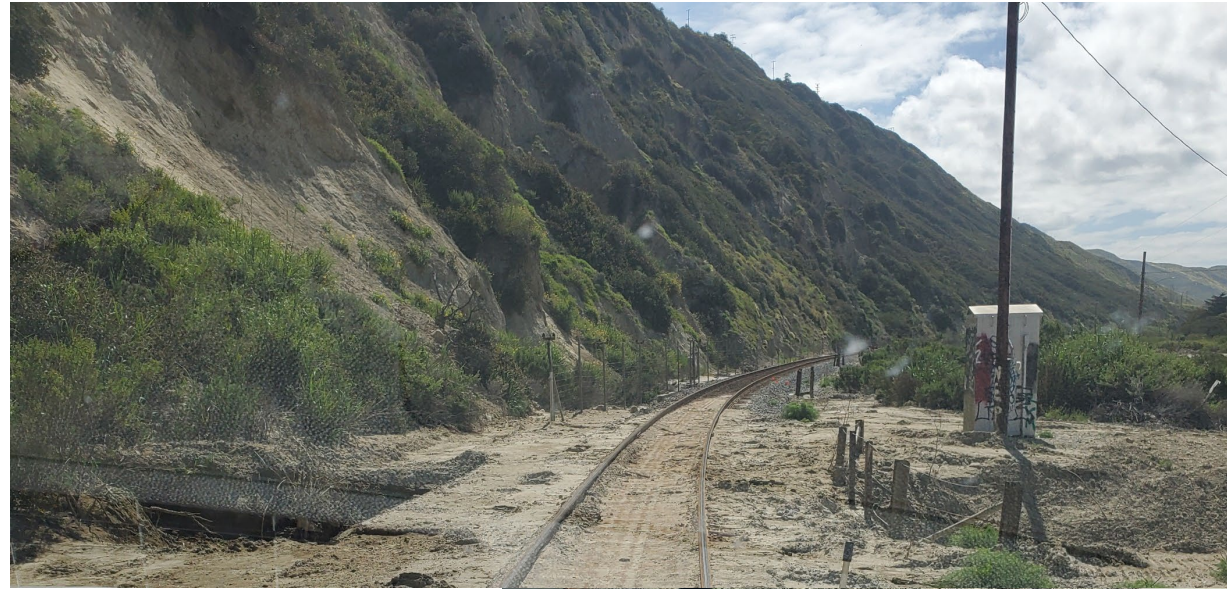
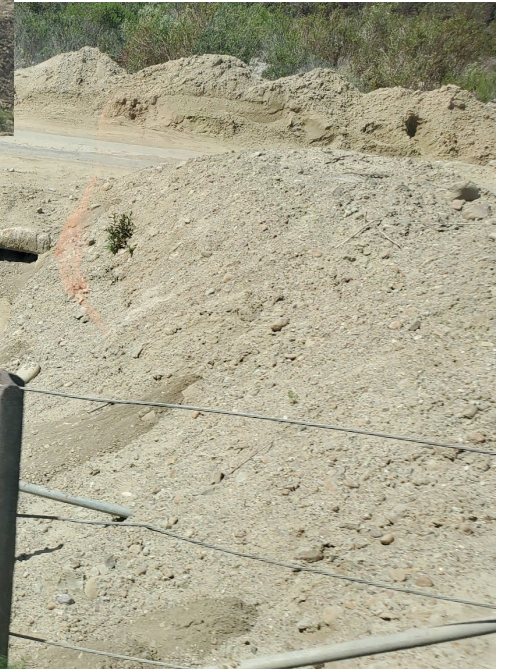
Rincon Point (Mile Post 381-382)

- Significant areas of hill erosion above the track area
- Tracks covered in sand after runoff from hills

- Vacuum track bed to remove sand and sediment

- Install storm water pipes from the farm field at top to bottom of slope
- May need easements to perform work
- Place of rocks, revetment to shore-up bottom of slope
